LQ Coil Fabrication at BNL

Jesse Schmalzle, BNL
CM12 – 4/9/09

LQ Coil Status

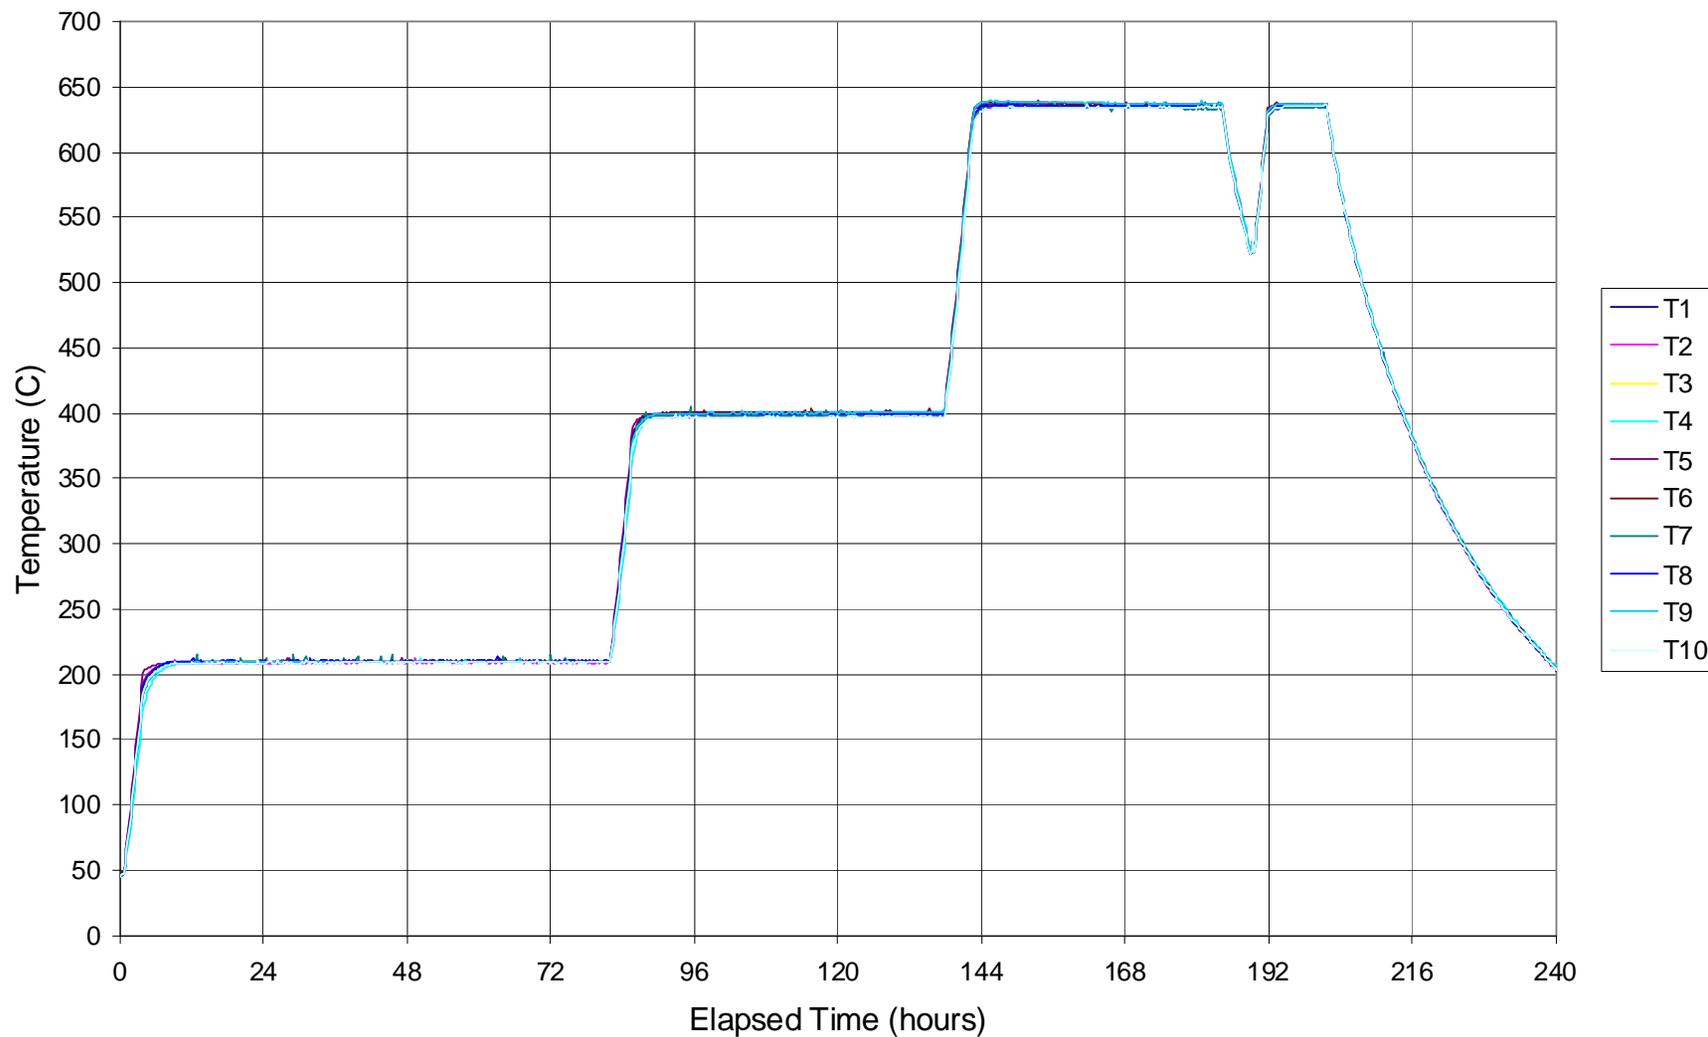
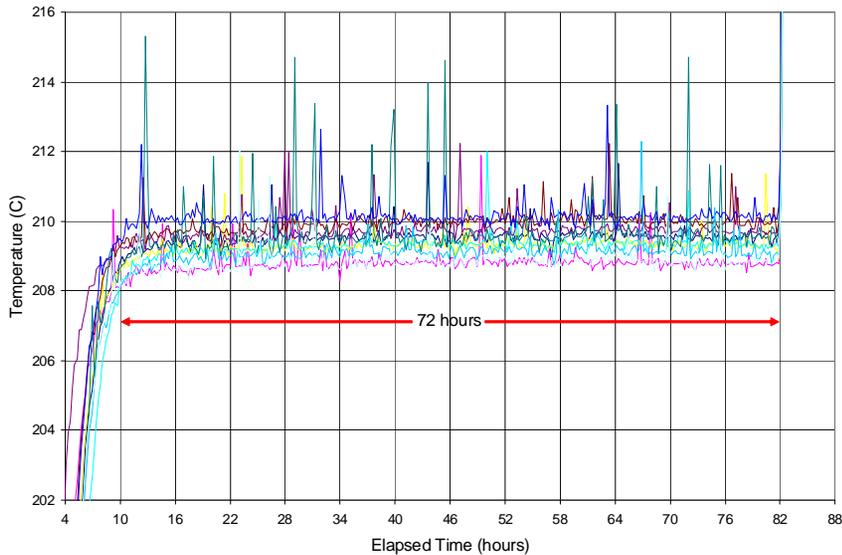
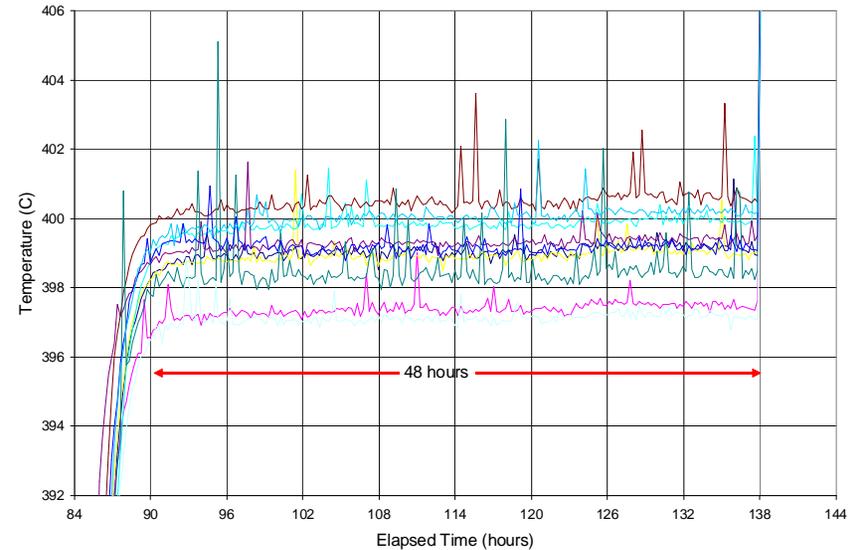
LQ07 - Reaction

- BNL site wide power failure completely shut down reaction cycle after 40 hours at 640C.
- Coil had cooled to 555C before Argon flow was manually restarted.
- Coil had cooled to 520C over 5.5 hours before power was restored.
- Coil was brought back to 640C and held for 8 hours to complete the 48 hour step.
- Temperature at 640C step was a little low, adjustment made for next coil.

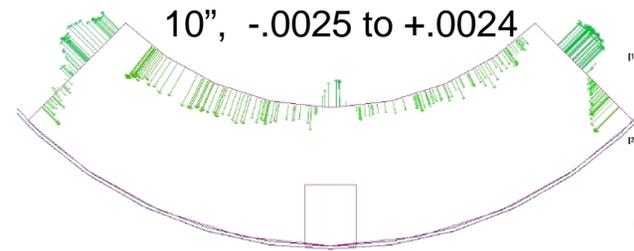
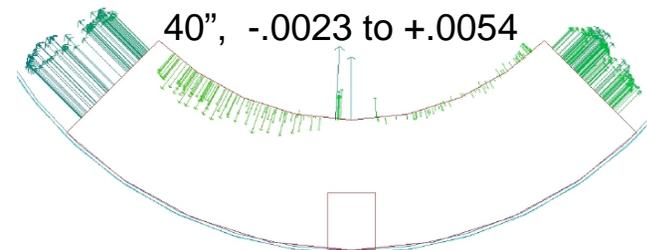
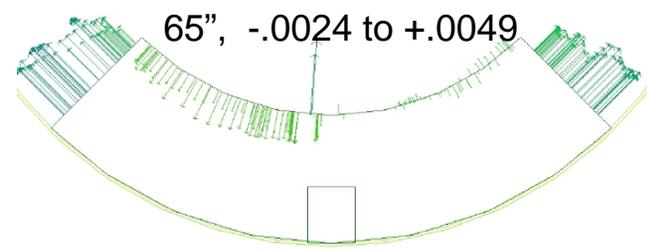
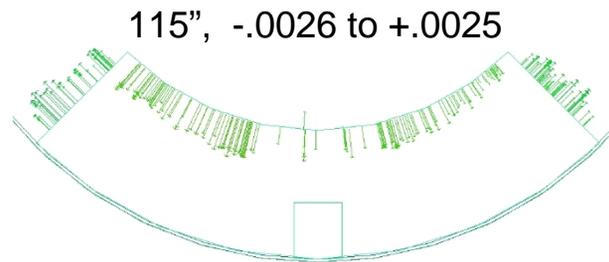
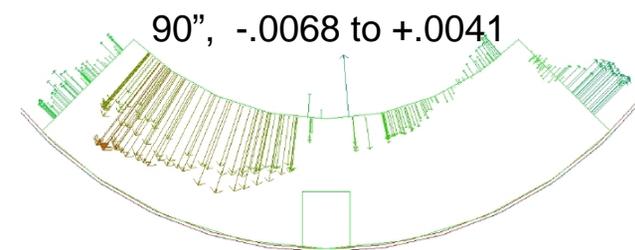
- Coil size measurements.
 - Coil clamped in form blocks.
 - Measured using portable CMM.
- Variations from nominal shown by arrows on plots.
 - Data fit to coil OD.
 - Measured variations on midplane are from .002" (.05mm) small to .005" (.13mm) large.

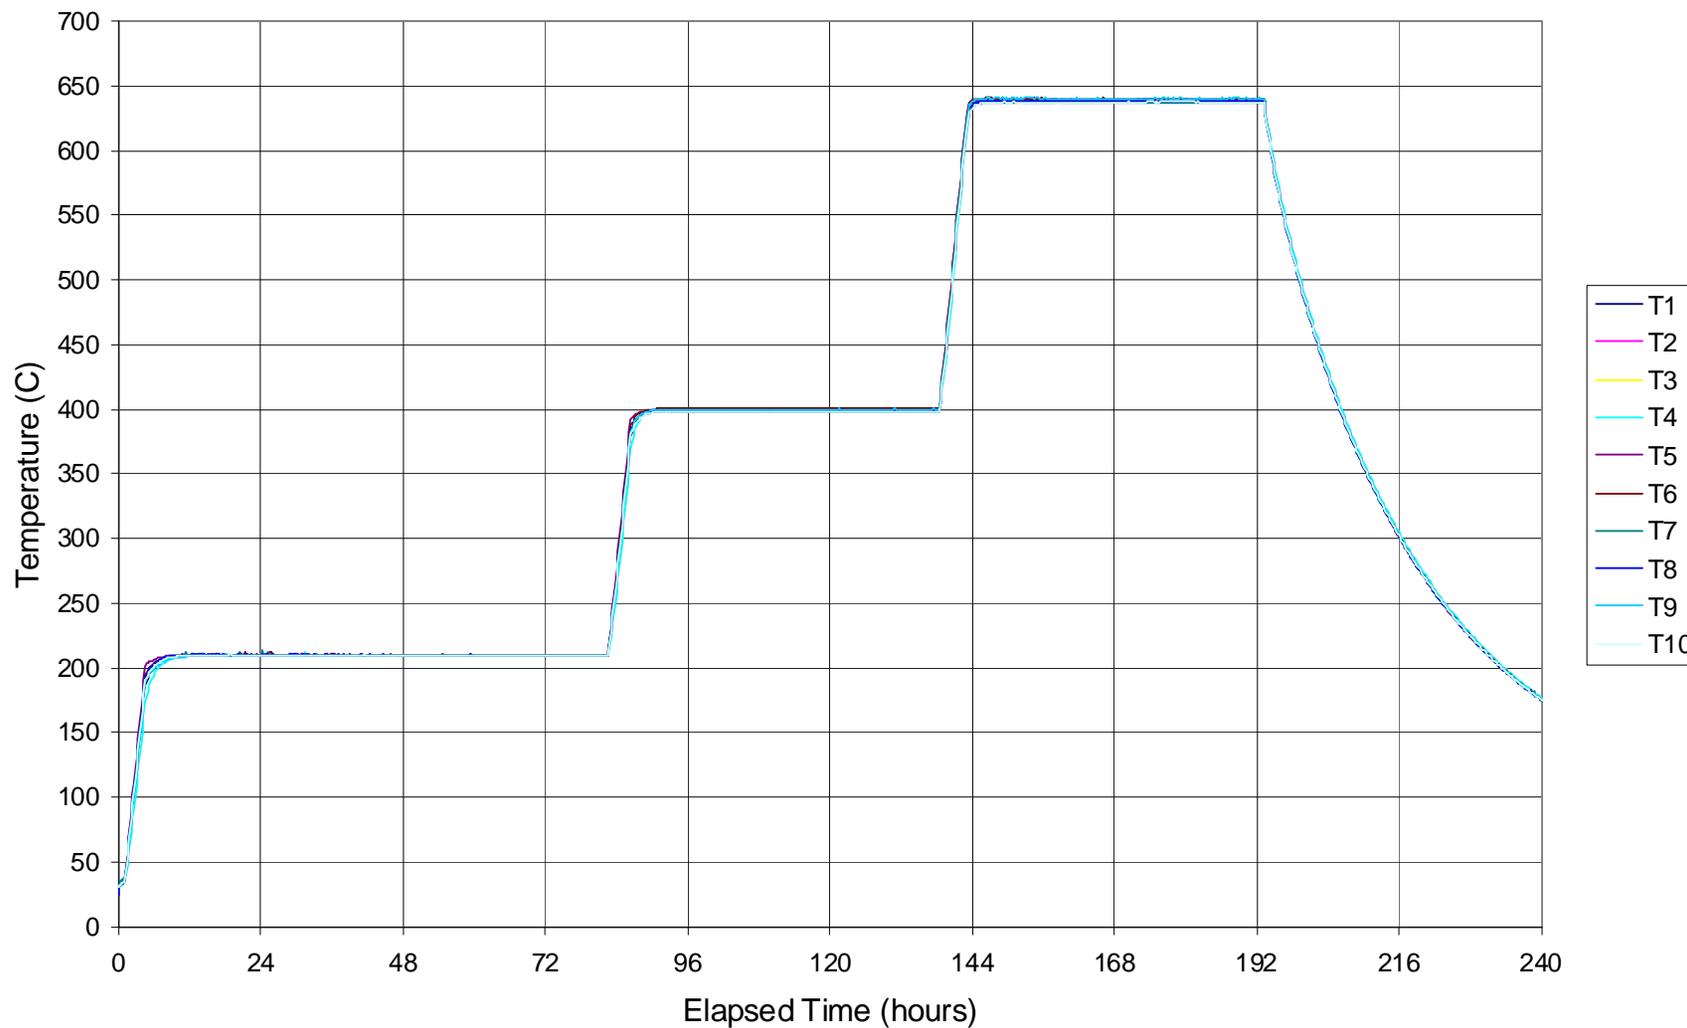
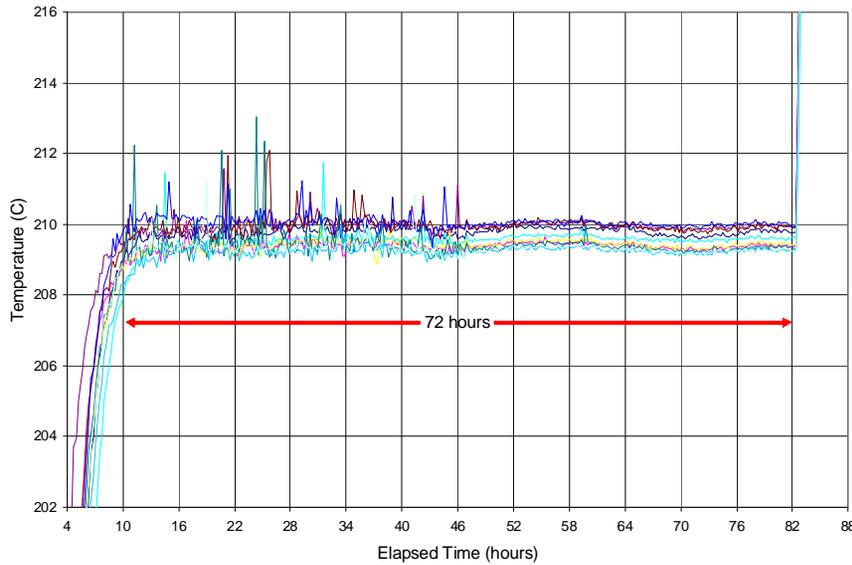
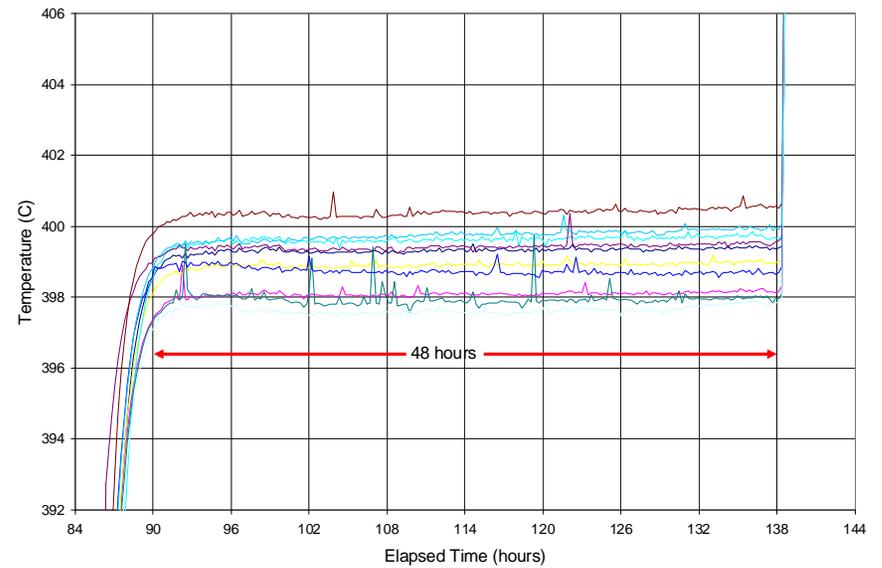
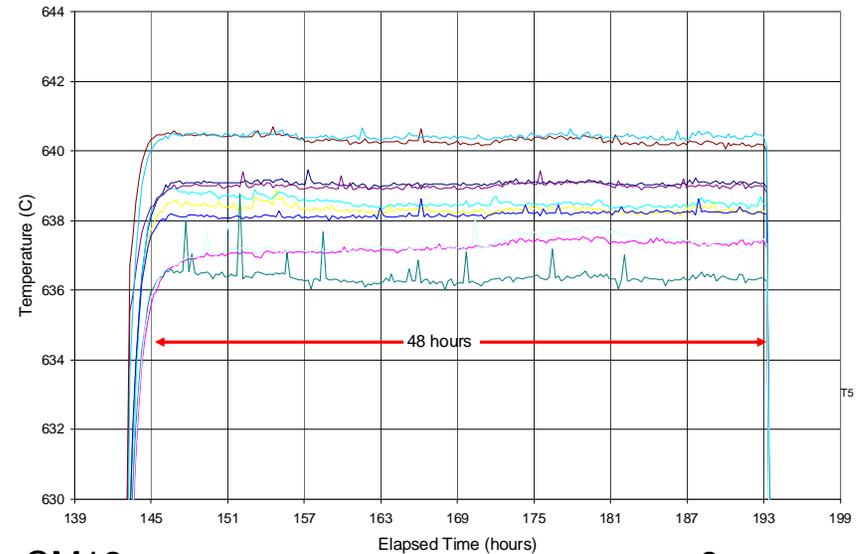
LQ09 - Reaction

- Signal interference abruptly stopped mid way through 210C step.
 - Will investigate cause before next reaction.
