LQ Coil Fabrication at BNL

Jesse Schmalzle, BNL
CM12 – 4/9/09

LQ Coil Status

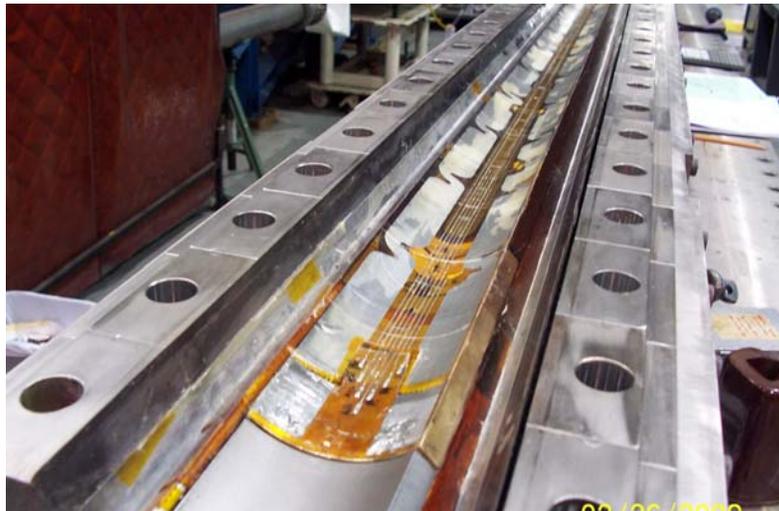
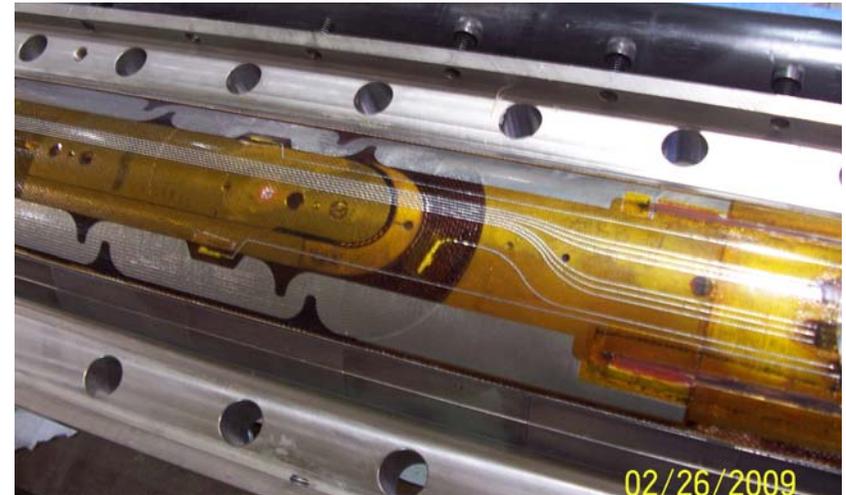
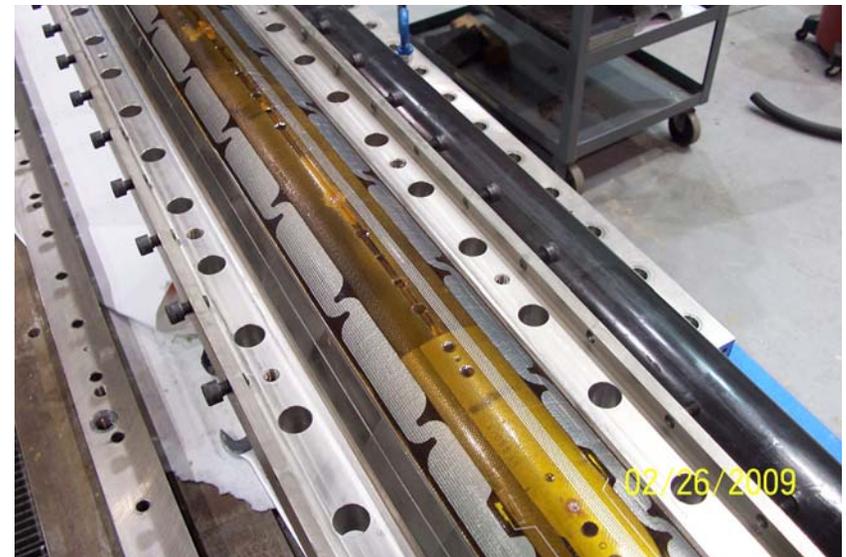
- Impregnation quality looks good.
- Electrical checks:
 - Coil shorted to outer layer LE brass saddle – use as is.
 - Heater shorted to LE outer layer brass saddle – repaired
 - Heater shorted to outer layer NL brass saddle – use as is.
 - Extra insulation being added for next coil.

- Coil size measurements.
 - Coil clamped in form blocks.
 - Measured using portable CMM.
- Variations from nominal shown by arrows on plots.
 - Data fit to coil OD.
 - Measured variations on midplane are from .002" (.05mm) small to .005" (.13mm) large.
